Project Title: *The John Deere E diesel Test & Research Project*

Durability Test Results of Three Non-Road Tier II Diesel Engines Operating on 10% Ethanol-90% Diesel Blend

Final Report

October 2006

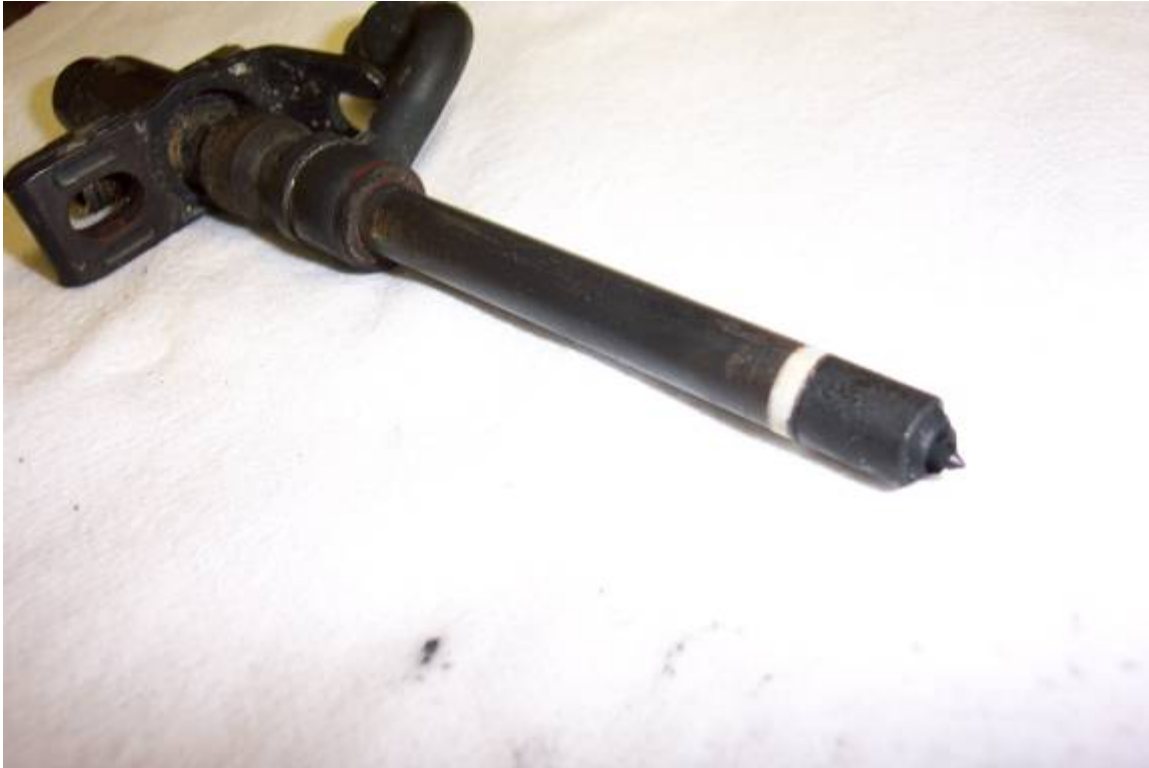
Figure I - 6.8L Engine #5 Injector Tip Failure

- Started test 13 July 2005
- Power loss caused by #5 injector tip failure @ 97 hours; replaced #5 injector
- Test cell fire caused by ruptured test cell fuel return line @ 170 hours
- Power loss caused by #4 injector tip failure @ 177 hours; replaced all injectors

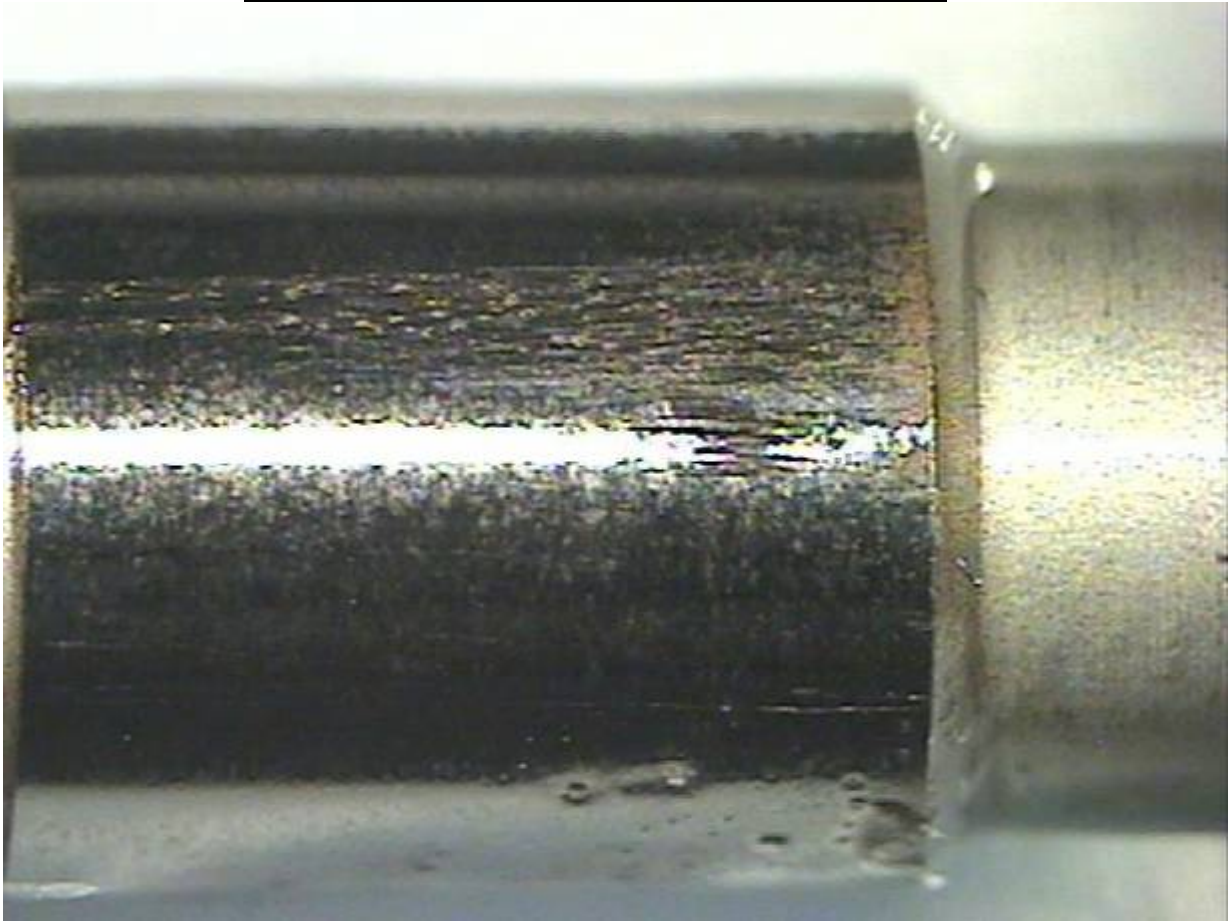
Figure II- 8.1 Liter Injector Command Piston Scuff

The suspect injectors were returned to Denso for diagnosis. The injectors were found to be intermittently functional and inspection revealed internal deposits, wear and command piston scuffing (Figure II)

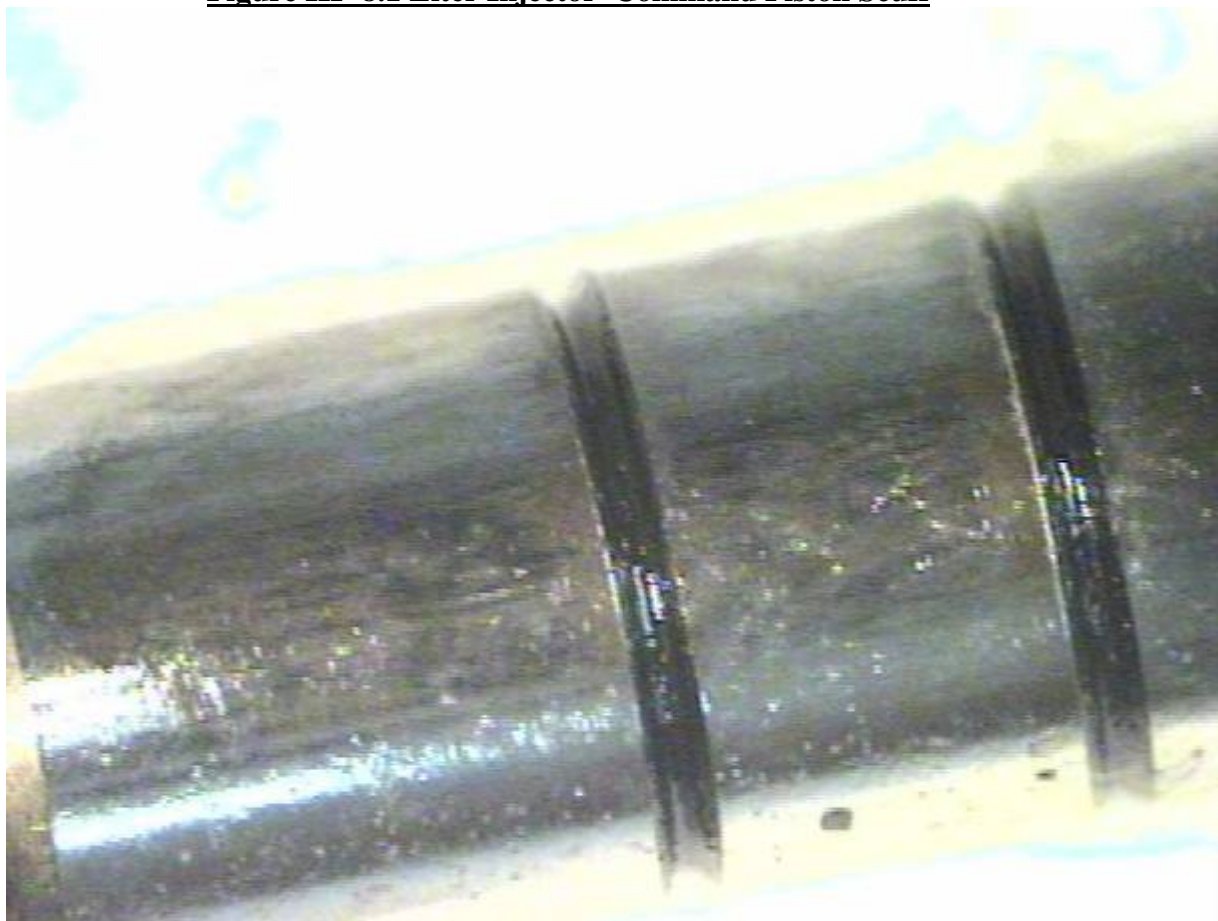
Figure III- 8.1 Liter Injector Command Piston Scuff

Run #2 of the 8.1 Liter engine operated between 02 November 2004 and 06 December 2004. Power levels started out at 99% of rated power and gradually deteriorated to 90% of test start by 500 hours. Hard starting was noted at 440 hours and the engine was unable to complete the scheduled 500 hour emissions test. Diagnostics again indicated faulty injectors and they were returned to Denso for in-depth analysis. The inspection results were similar to the injectors from Run #1.

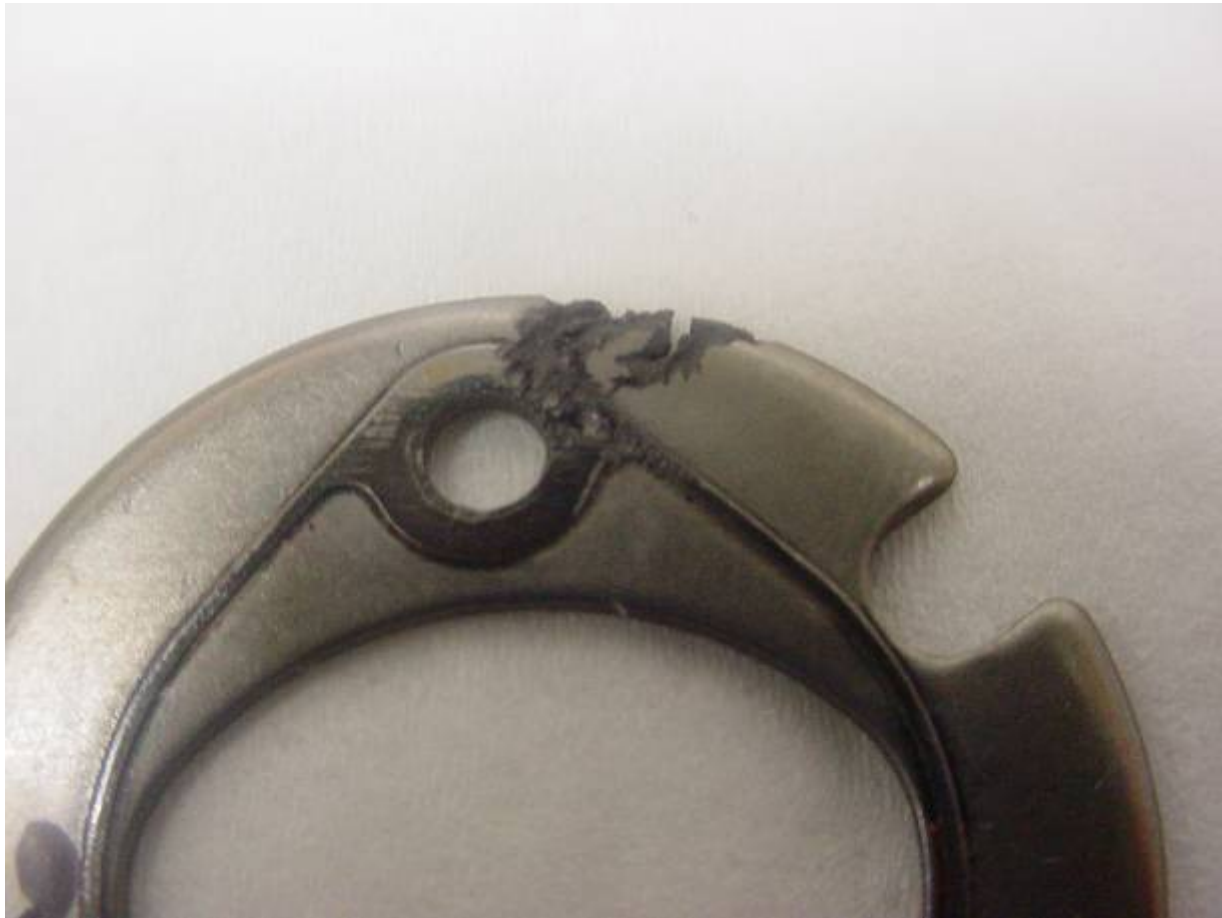
Figure IV- 12.5 Liter EUI Cavitated Internal Injector Sealing Surface

- Start test 08 June 2004
- 8% power loss @ 120 hours
- 10% power loss by 306 hours; diagnosed malfunctioning injectors
- Terminated test 02 August 2004
- observed cavitated internal high pressure injector seals

- The Delphi electronic unit injectors (EUI) used in the 12.5 Liter engine failed due to cavitation erosion of the high pressure internal sealing washers. The higher vapor pressure property of E diesel is the apparent direct cause of this observed weakness. Fuel cooling effectiveness is limited by the routing of the fuel supply through the cylinder head. Testing at fuel supply pressures in the 200 psi region remains to be explored. Redesigned injectors, an external fuel supply rail design allowing higher charging pressures yet and uses of more effective fuel cooling are features that could provide improved injector life.

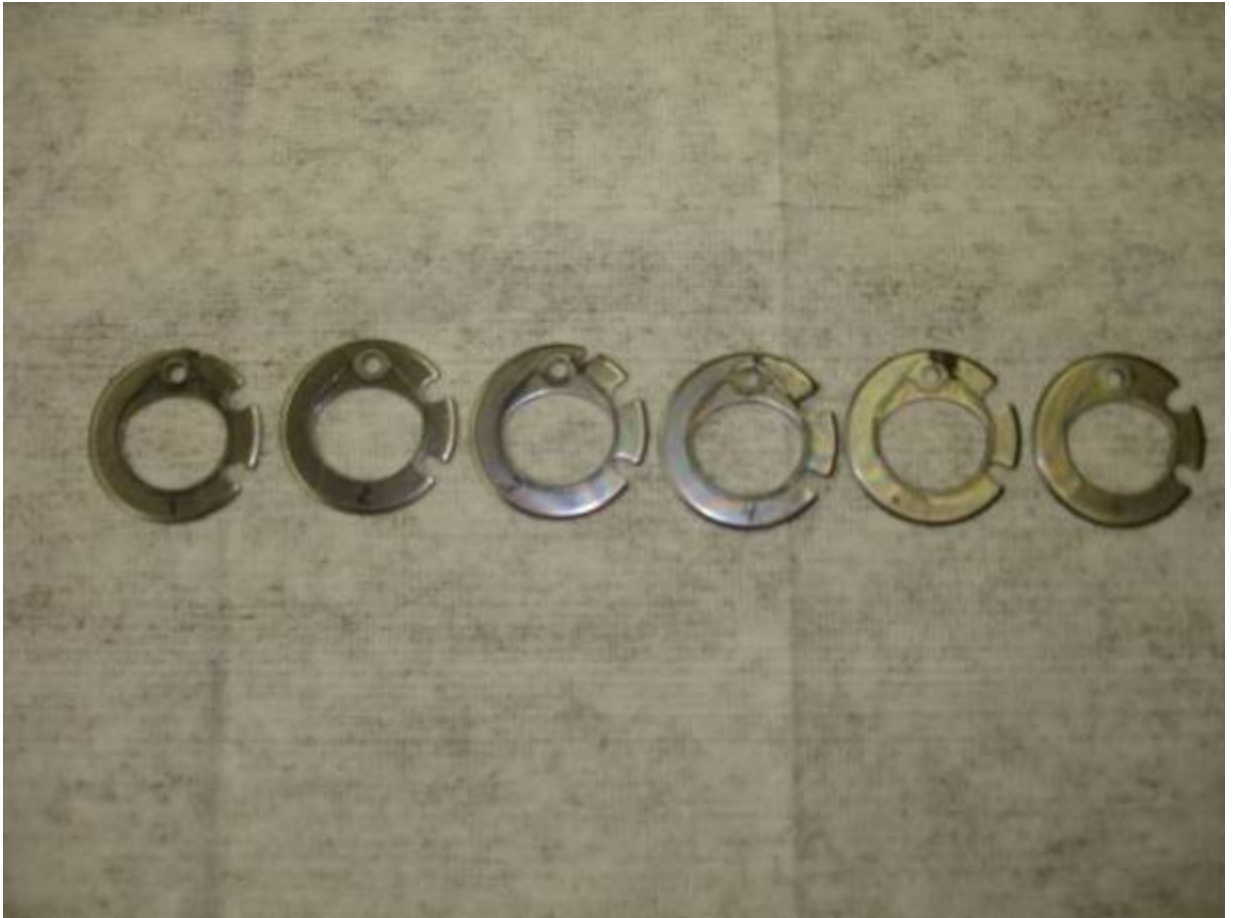
Figure V - 12.5 Liter EUI Cavitated Internal Injector Sealing Rings-
Run #2

- Start Run #2 17 February 2006 with new injectors; increased fuel rail charge pressure; improved fuel cooling
- Power/fuel rate loss; 8-15% 24 February 2006 @ 166 hours
- Same injector cavitation failure mode as Run #1
- Terminated test on 06 March 2006.

Run #2 of the 12.5 Liter engine was started on 17 February 2006 with the fuel cooling maximized and the fuel rail pressure increased to 827 kPa. 166 hours into the test sudden fuel rate and power drop indicated that internal cavitation may once again be a problem. Subsequent inspection of the injectors confirmed that all six internal sealing washers suffered cavitation damage (Figure V). The test was terminated. A listing of potential future work research on this fuel system could include:

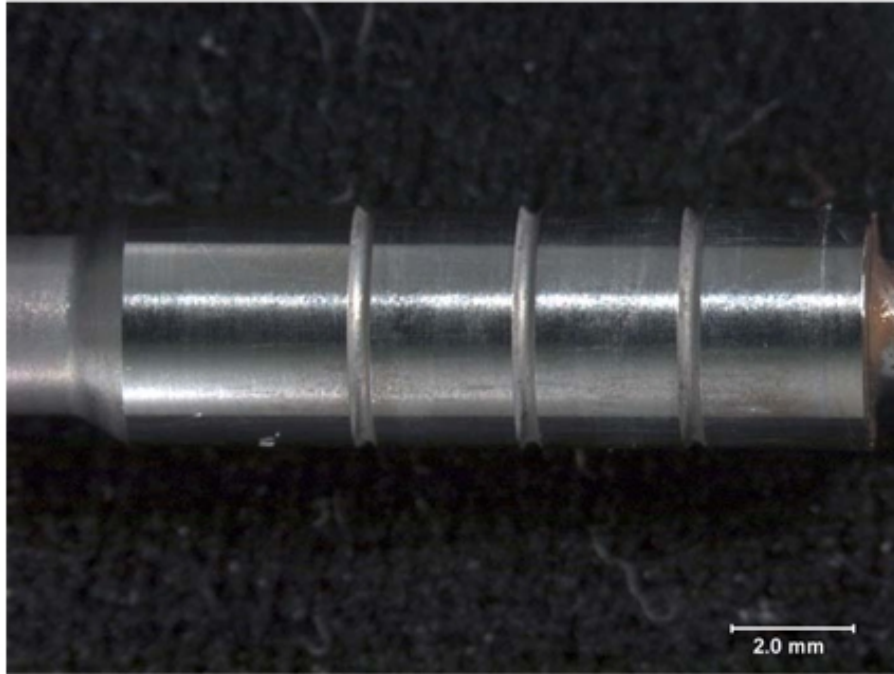
An overall view of the sliding surfaces on the needle from run 1, injector 1 is provided in Figure 1(a). The surfaces appeared to be in good condition with no apparent evidence of galling. Examination at higher magnifications identified the presence of some small longitudinal score marks, as shown Figures 2(a) and 3(a). The surfaces appeared to be relatively free of surface deposits. Furthermore, no evidence of environmental attack was observed.

Figure 1. Overall views of the sliding surfaces on the needles from (a) run 1, injector 1 and (b) run 2, injector 5.

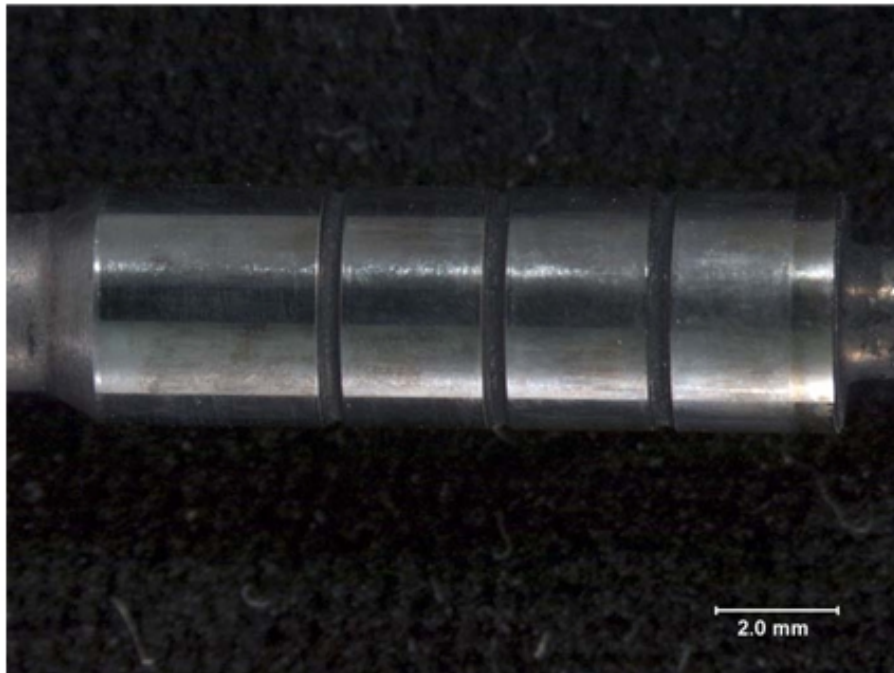
(b)

An overall view of the sliding surfaces on the needle from run 2, injector 5 is provided in Figure 1(b). A narrow band along the upper end of the needle, far right in Figure 1(b), appeared to be free of any wear damage. The remainder of the surface was dulled from wear damage. Examination at higher magnifications identified extensive longitudinal scoring, as shown in Figures 2(b) and 3(b). The scoring was the deepest and most extensive along the upper surfaces.

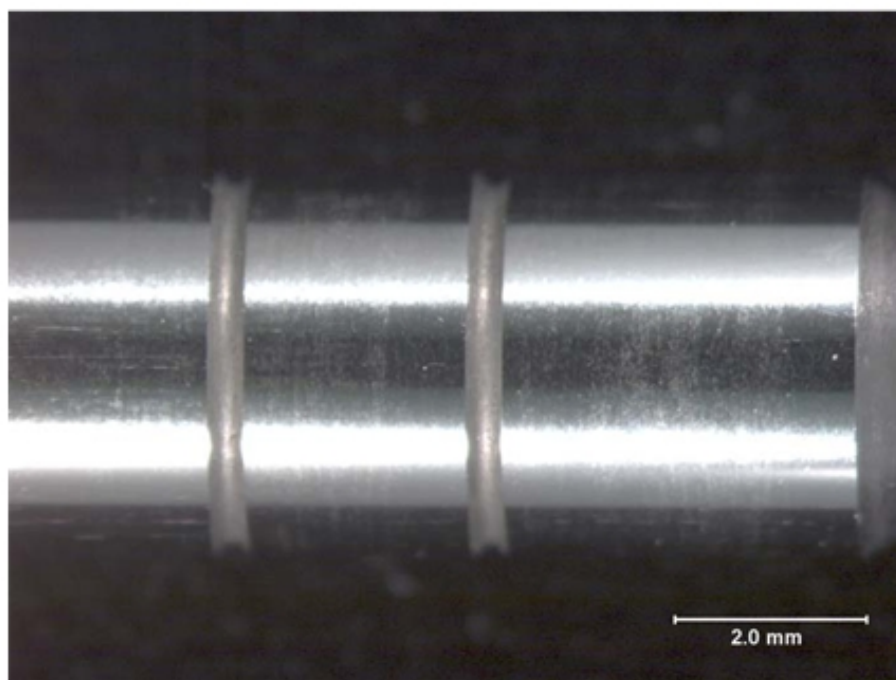
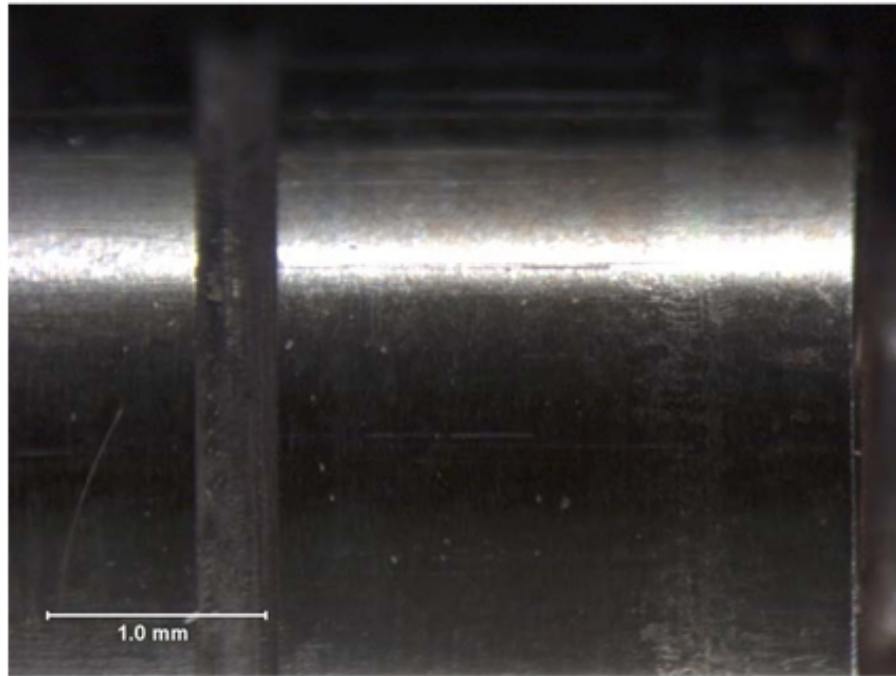
Figure 2. Intermediate magnification stereomicroscope images of the upper end of the sliding surfaces on the needles from (a) run 1, injector 1 and (b) run 2, injector 5.

Figure 3. High magnification stereomicroscope images of the upper end of the sliding surfaces on the needles from (a) run 1, injector 1 and (b) run 2, injector 5.

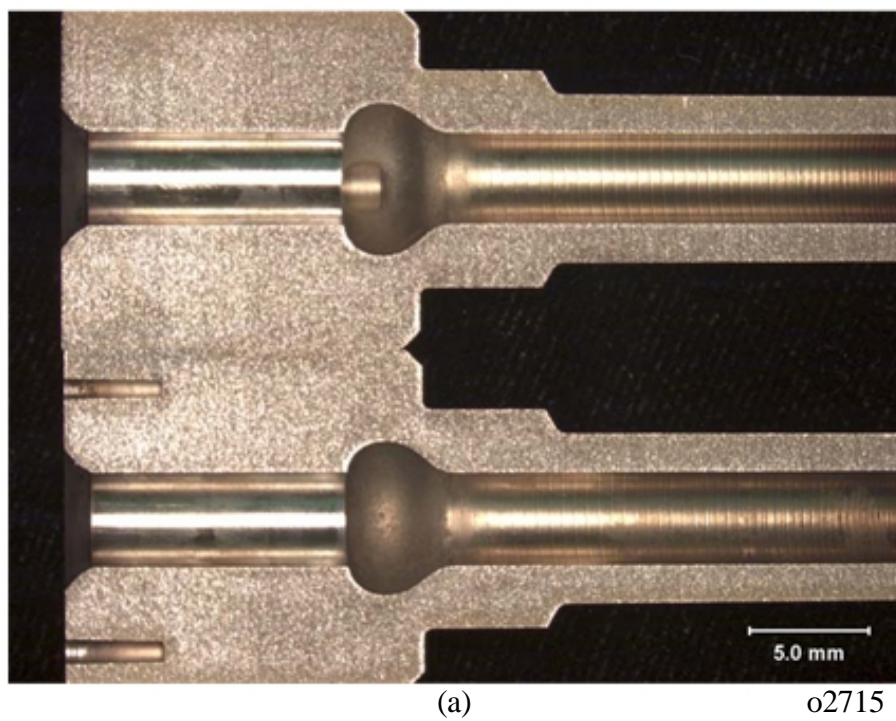
The injector body was longitudinally sectioned using a wire EDM. The two halves of the sectioned body from run 1, injector 1 are shown in Figure 4(a). The wear surfaces, located on the left side of the photograph, were quite smooth and free of any significant deposits. The original honing marks were the prominent feature observed during higher magnification examinations, as shown in Figure 5. Some light longitudinal scoring was also apparent. Portions of the bore exhibited a lightly etched appearance, as shown in Figure 7(a).

Figure 4. Overall views of the inside surfaces of the sectioned injector bodies from (a) run 1, injector 1 and (b) run 2, injector 5.

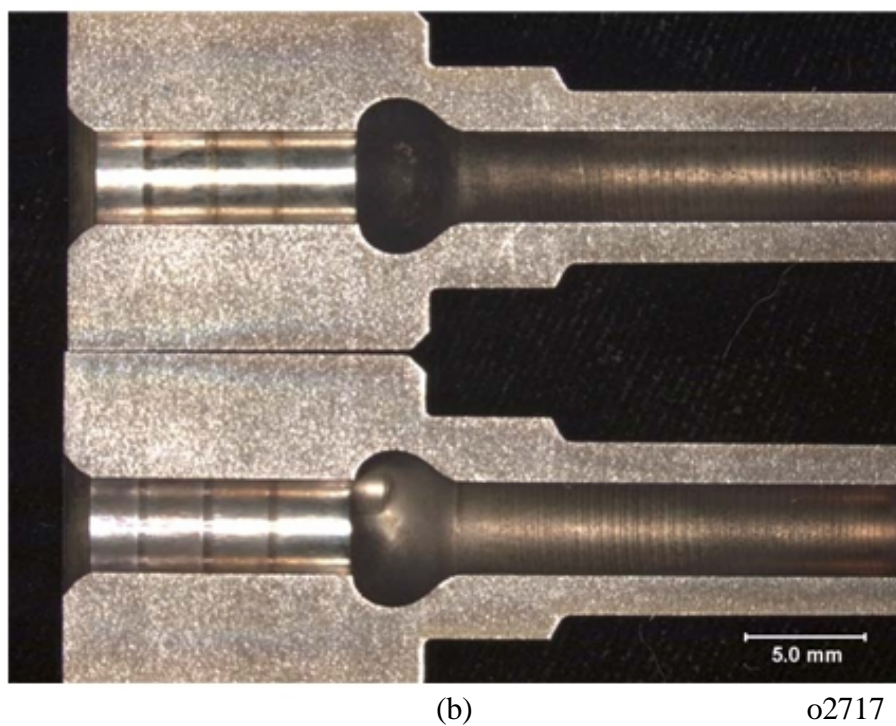
The injector body was longitudinally sectioned using a wire EDM. The two halves of the sectioned body from run 2, injector 5 are shown in Figure 4(b). The wear surfaces are located on the left side of the photograph. Three dark circumferential bands, apparently corresponding to the three grooves on the needle surface, were apparent. Significant differences between the two sectioned halves were apparent at higher magnification. One side, shown in Figure 6(a), exhibited deep longitudinal grooving to such an extent that all of the original honing marks had been removed. On the opposite side, shown in Figure 6(b), honing marks were still visible and only a small amount of longitudinal grooving was present. Areas that appeared to be shallow corrosion pits filled with corrosion product were also evident on the low wear side of the bore, as shown in Figures 6(b) and 7(b).

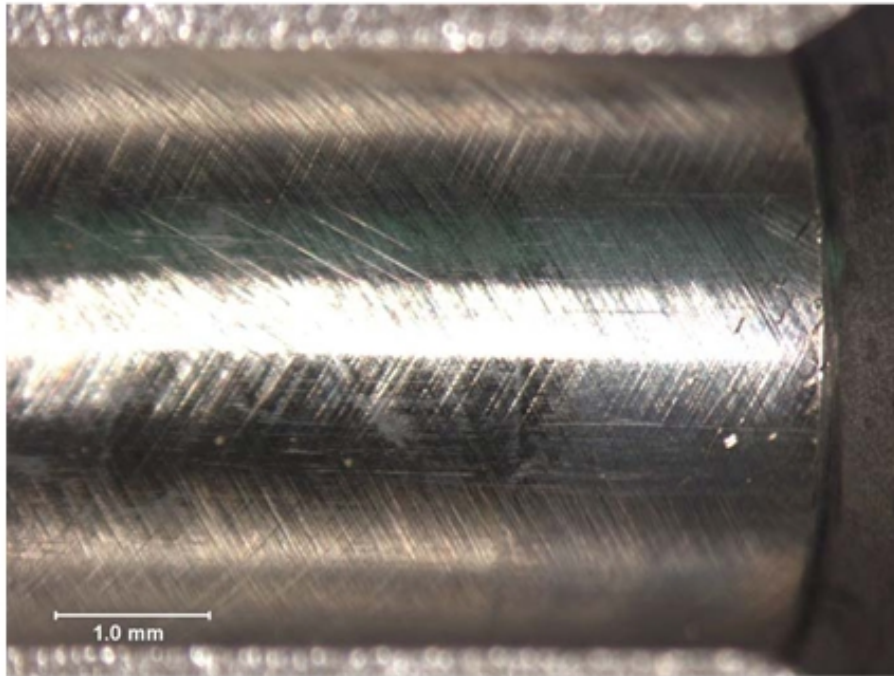
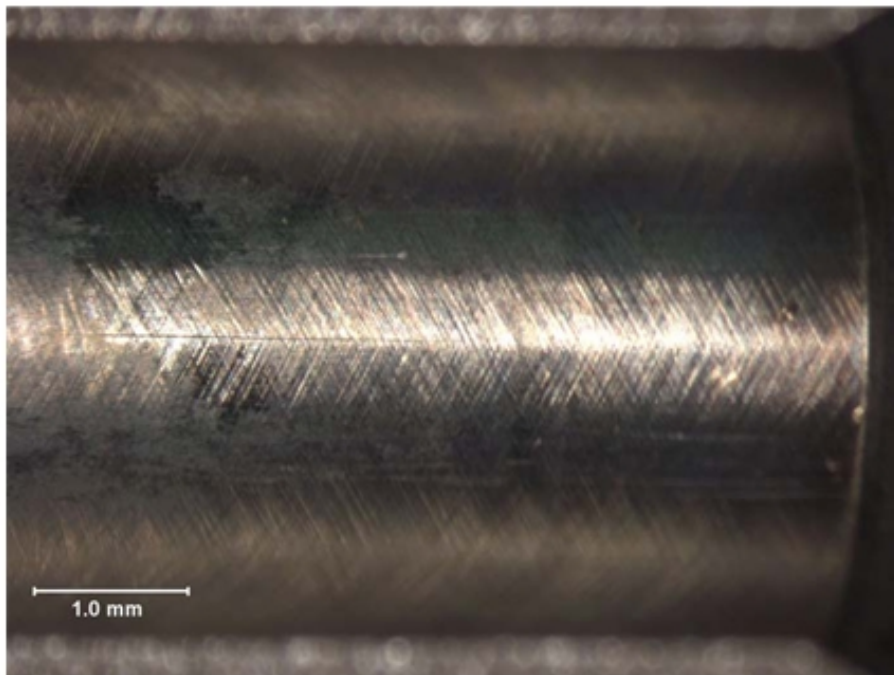
Figure 5. Higher magnification stereomicroscope images of opposite sides of the inside surface of the injector body from run 1, injector 1.

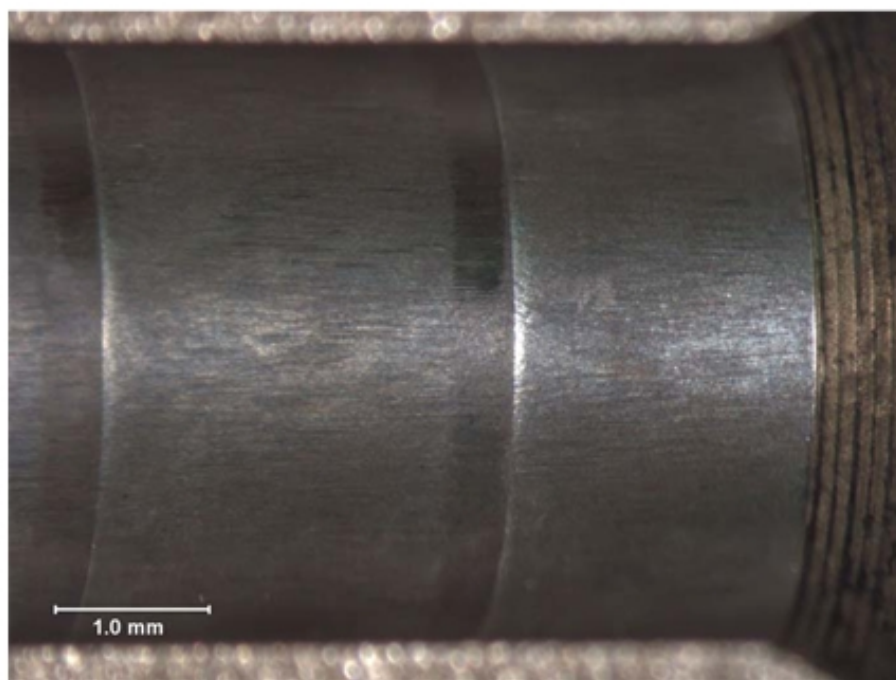
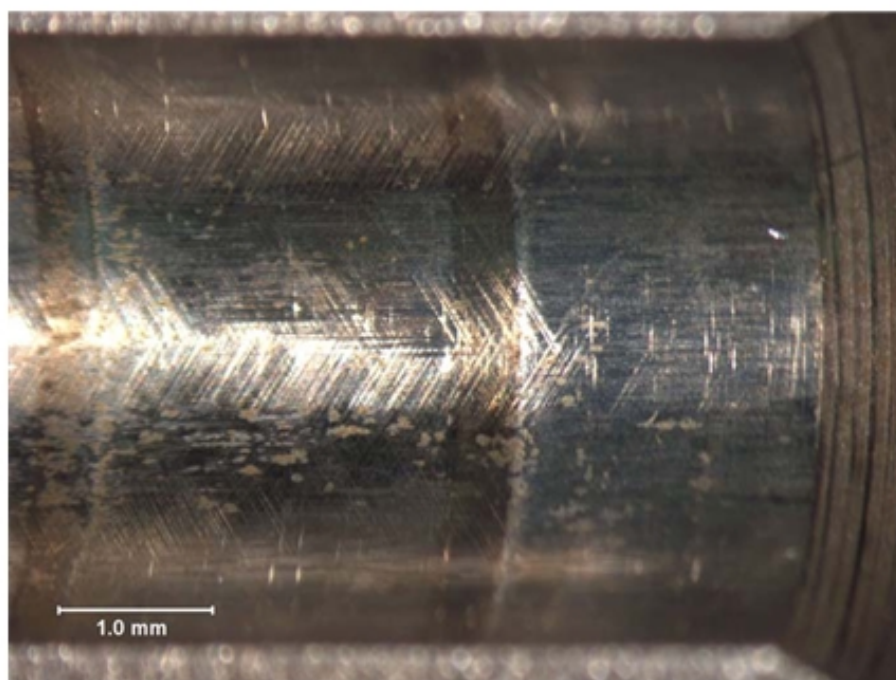
Figure 6. Higher magnification stereomicroscope images of opposite sides of the inside surface of the injector body from run 2, injector 5.

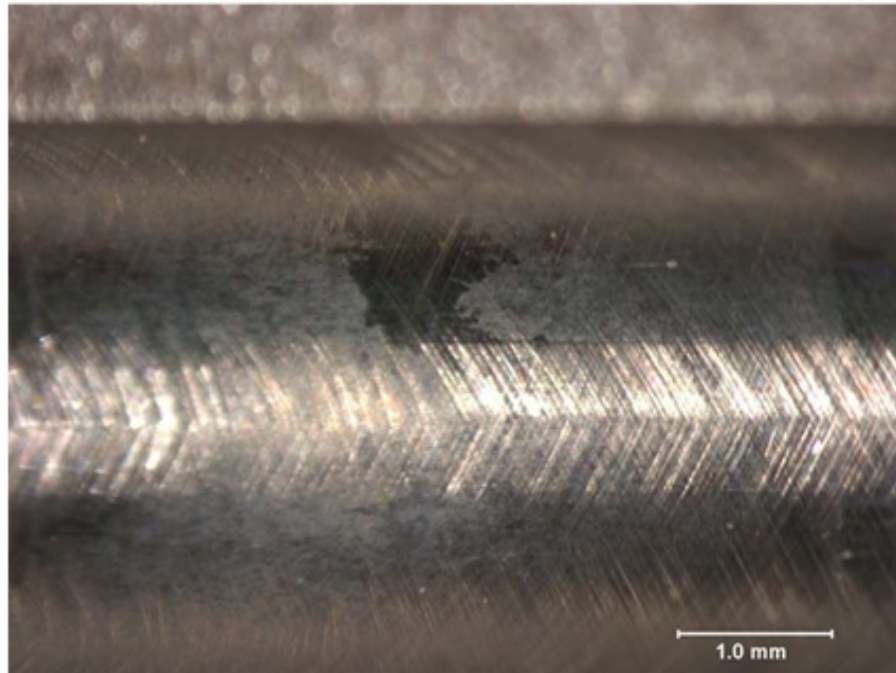
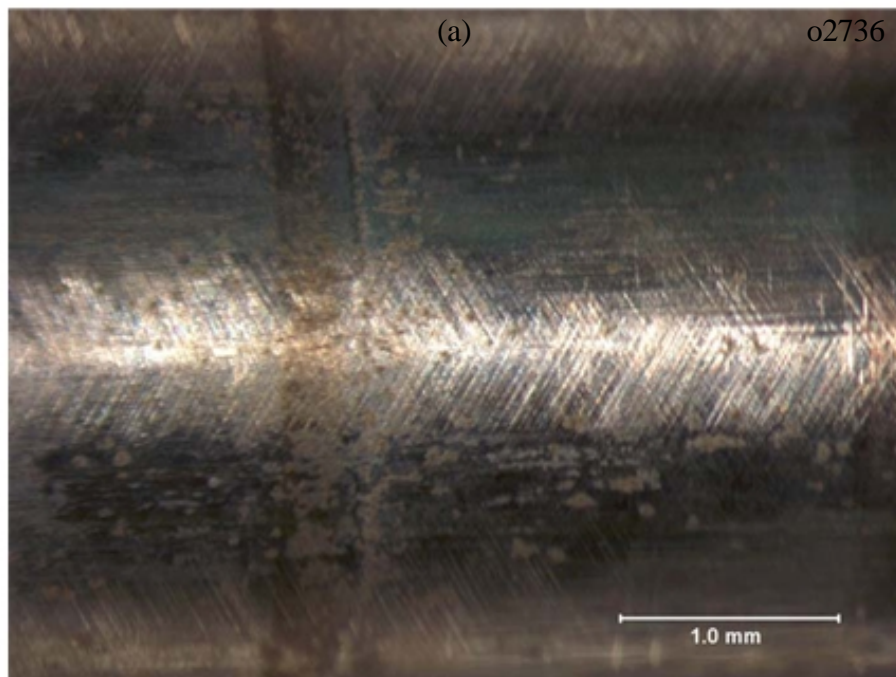
6. Both injectors exhibited evidence of corrosive attack of the bore surface. The attack on run 1, injector 1 was in the form of a very light etching and did not appear to affect the performance of the injector. The attack on run 2, injector 5 was in the form of scattered pitting and was clearly sufficient to degrade injector operation. Sulfur and chlorine species in the fuel appeared to be responsible for the pitting.

Figure 7. Stereomicroscope images of (a) apparent etching and (b) pitting on the inside surfaces of the injector bodies from run 1, injector 1 and run 2,

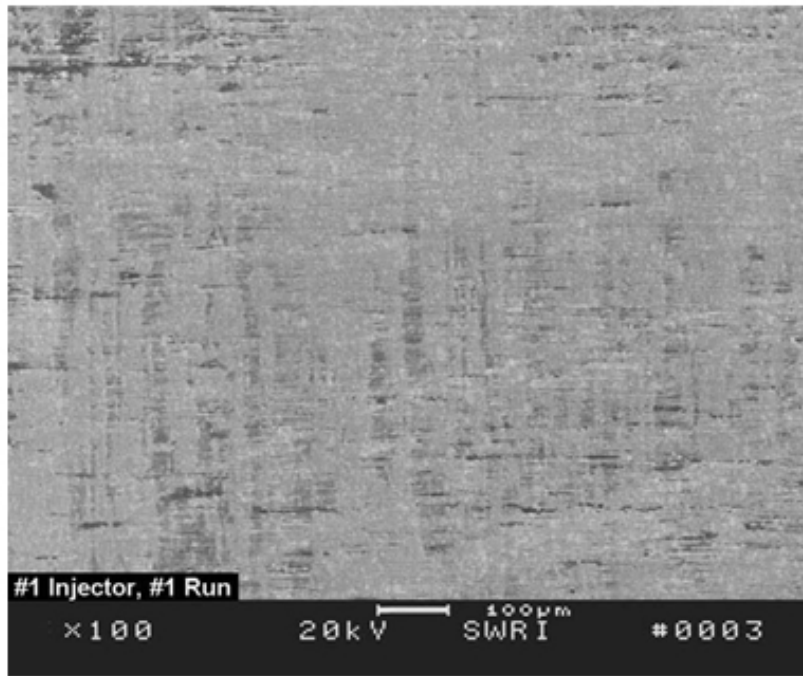
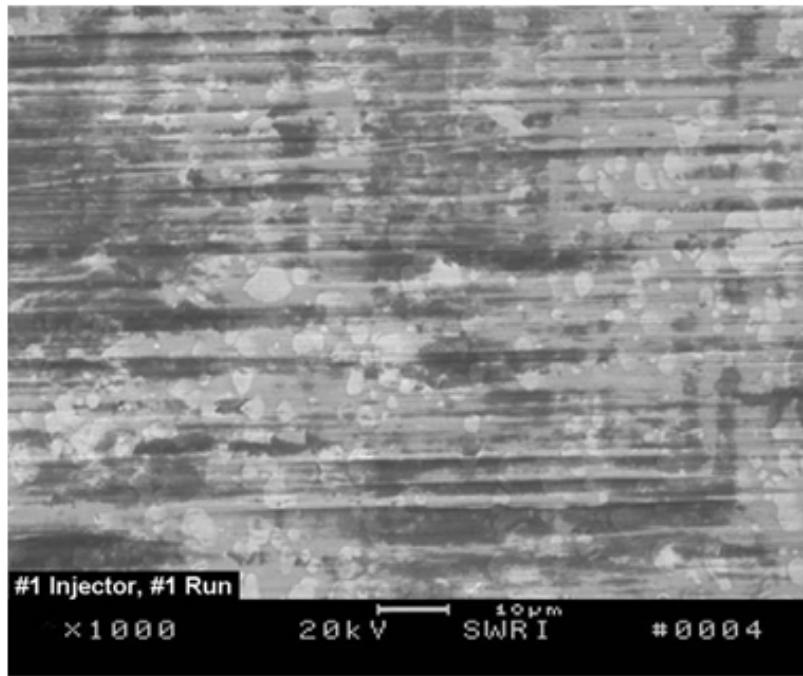
Examination of the needle surfaces of run 1, injector 1 revealed fairly smooth surfaces that exhibited minimal wear. Extensive scoring was not evident, as shown in Figure 8(a), and the original machining marks were still visible on the surface, as shown in Figure 9(a). Second phase particles were evident, however, no evidence of particle pull-out was observed.

Figure 8. Scanning electron microscope images of the sliding surfaces on the needles from (a) run 1, injector 1 and (b) run 2, injector 5. The sliding direction is vertical.

Figure 9. High magnification scanning electron microscope images of the sliding surfaces on the needles from (a) run 1, injector 1 and (b) run 2, injector 5. The sliding direction is vertical.

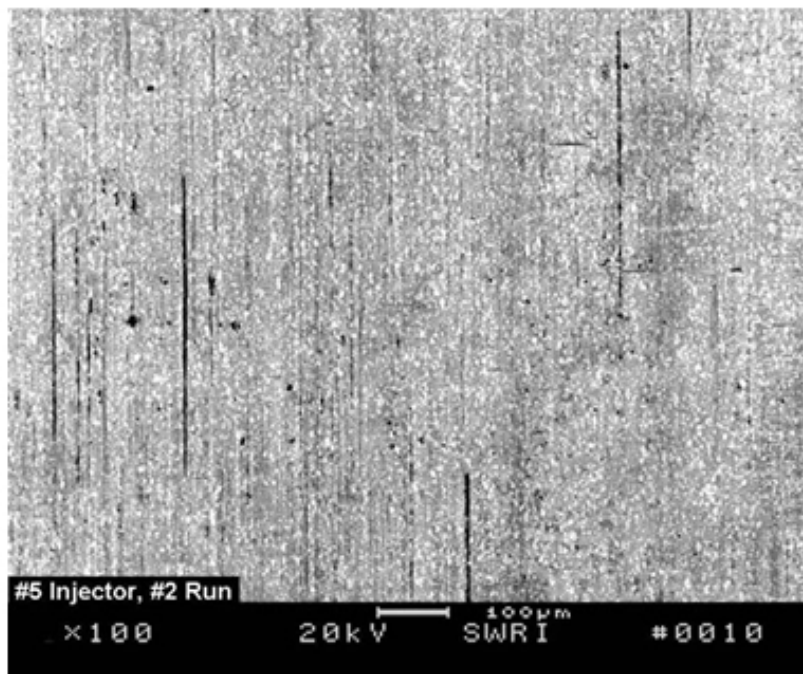
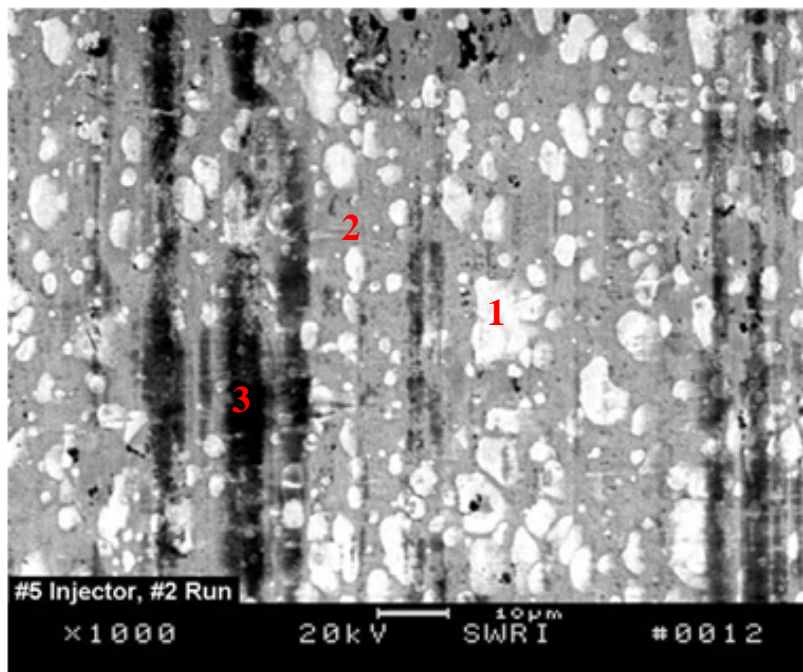
Examination of the needle surfaces of run 2, injector 5 revealed substantial longitudinal scoring, as shown in Figure 8(b). When viewed at higher magnification, Figure 9(b), second phase particles were evident along with dark, longitudinal streaks. Additionally, sufficient wear had taken place to remove all of the original machining marks from the surface.

3. The run 2, injector 5 needle and bore surfaces exhibited extensive wear damage. Wear damage was present in the form of deep longitudinal grooves. The grooves appeared to be the result of third body abrasive wear, possibly from tungsten particles removed from the needle surfaces during wear.

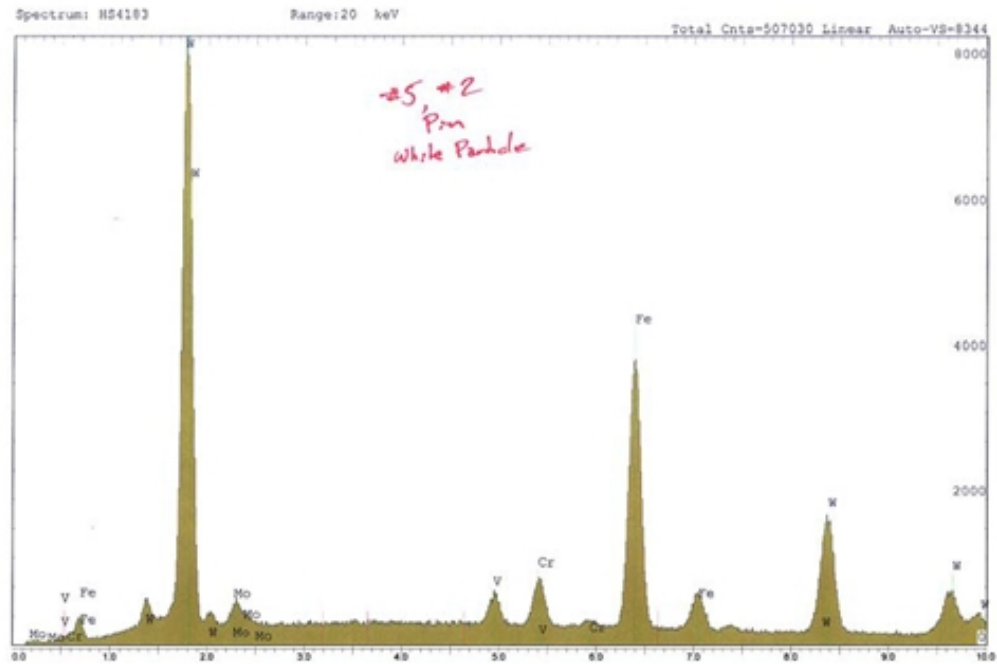
Figure 10. EDS spectrum from location 1 in Figure 9(b).

Examination of the second phase particles using energy dispersive x-ray spectroscopy (EDS) indicated that they were enriched in W, as shown in Figure 10. The matrix between the particles was iron based with small amounts of Cr, V, W and Mn, as shown in Figure 11. EDS measurements performed within the dark streaks, Figure 12, did not reveal any species besides those from the base alloy. For comparison, an EDS spectrum from an unworn area at the top of the needle, Figure 13, was also obtained. No significant differences were observed between this spectrum and those taken in the worn areas.

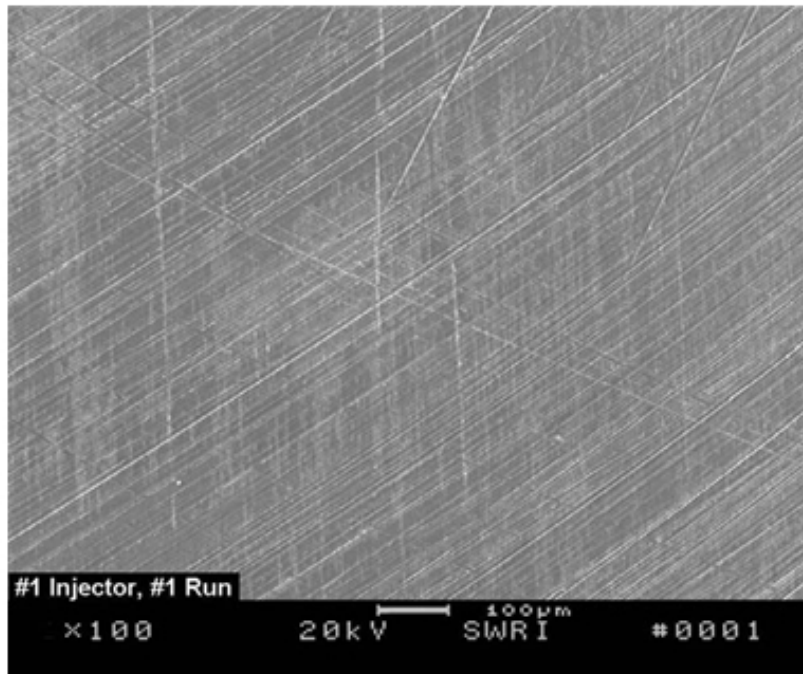
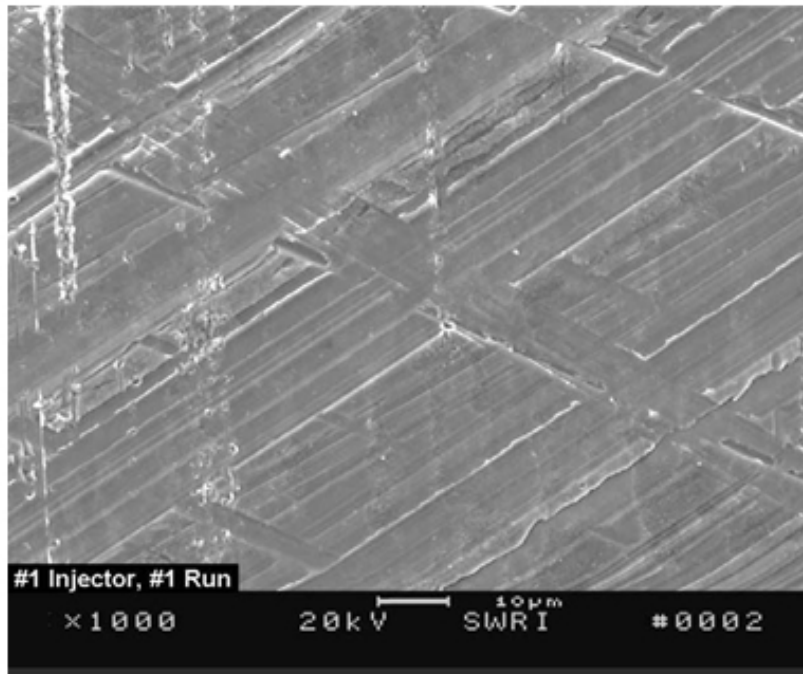
A cross-hatched pattern from honing was the predominant feature observed on the run 1, injector 1 bore surfaces in the SEM, as shown in Figures 14(a) and 15(a). Scattered, shallow score marks were also present. The surface regions that appeared to be lightly etched in the stereomicroscope exhibited a lightly textured appearance between the honing marks, Figure 16(a), compared to the smooth appearance between the honing marks observed outside of the etched regions, Figure 16(b).

2. Light wear damage, in the form scattered, shallow longitudinal score marks, was present on the needle and bore surfaces of run 1, injector 1. Localized regions of very light etching were also present on the bore surfaces.

Figure 14. Scanning electron micrographs of the inside surface of the sectioned injector bodies from (a) run 1, injector 1 and (b) run 2, injector 5. The sliding direction is vertical.

Figure 15. Higher magnification SEM images from the inside surface of the sectioned injector bodies from (a) run 1, injector 1 and (b) run 2, injector 5. The sliding direction is vertical.

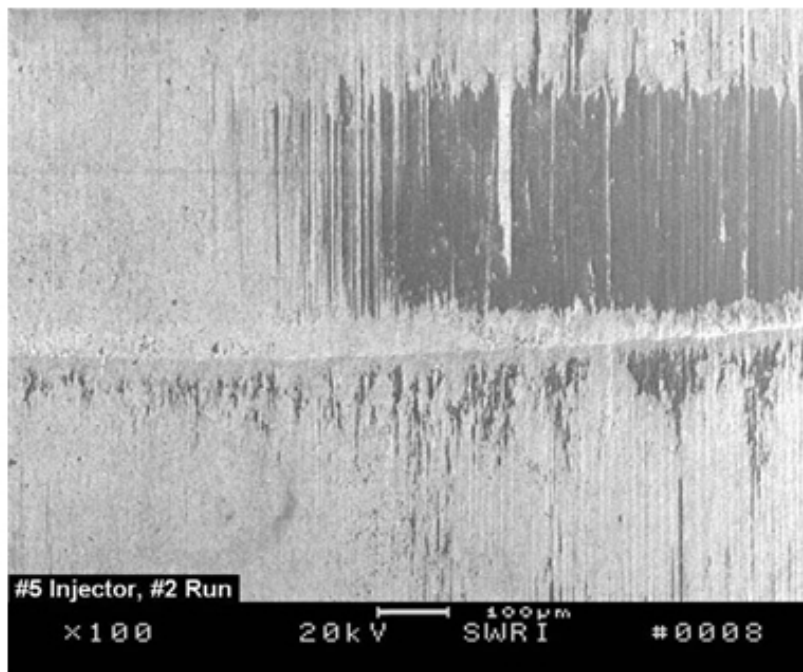
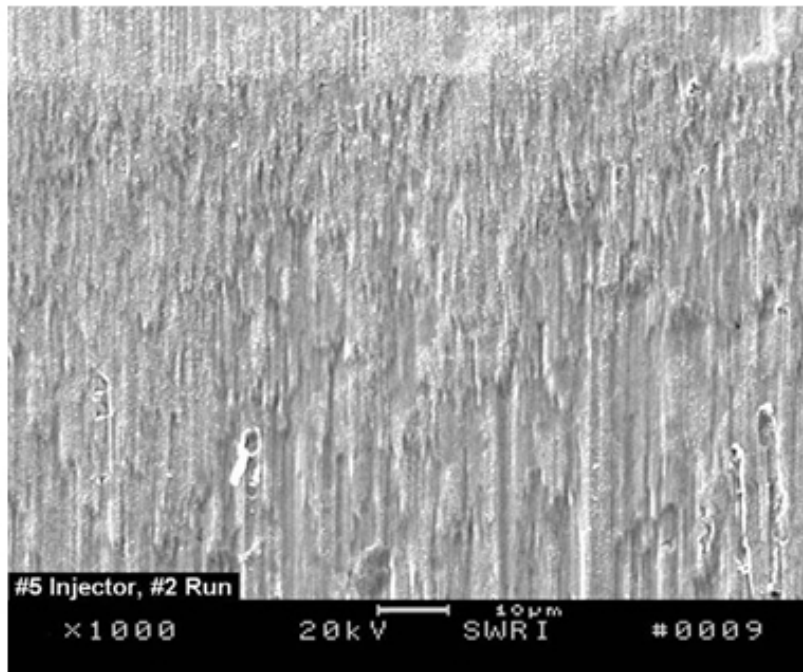
One side of the run 2, injector 5 bore exhibited extensive wear with the wear patterns corresponding to the geometry of the mating needle surfaces, as shown in Figure 14(b). The wear patterns were in the form of longitudinal grooving. When viewed at higher magnification, Figure 15(b), the wear surface had the appearance of third body abrasive wear with very fine particulates populating the surface. The opposite side of the bore exhibited only minimal wear as indicated by the presence of the original honing marks, as shown in Figure 17. Shallow, scattered score marks were present along with areas of deposit filled corrosion pits. Comparison of EDS spectra obtained from a clean area on the bore surface, Figure 18, and from within a pit, Figure 19, indicates that the deposits within the pits were iron oxides which contained minor amounts of P, S, Cl, K, Ca, Cu and Zn. The regions of dark deposits that surrounded the pits were found to contain C, P, S, Ca and Zn, as shown in Figure 20.

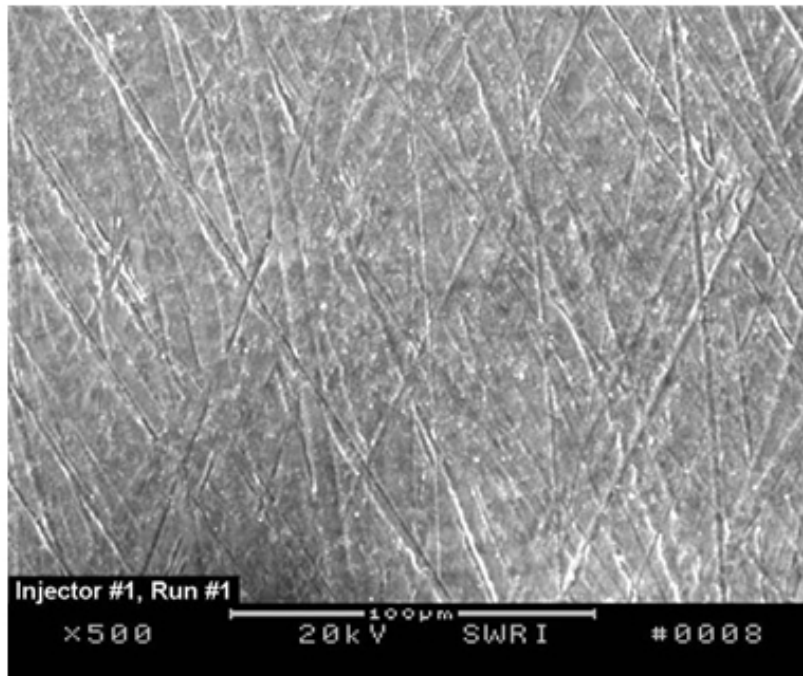
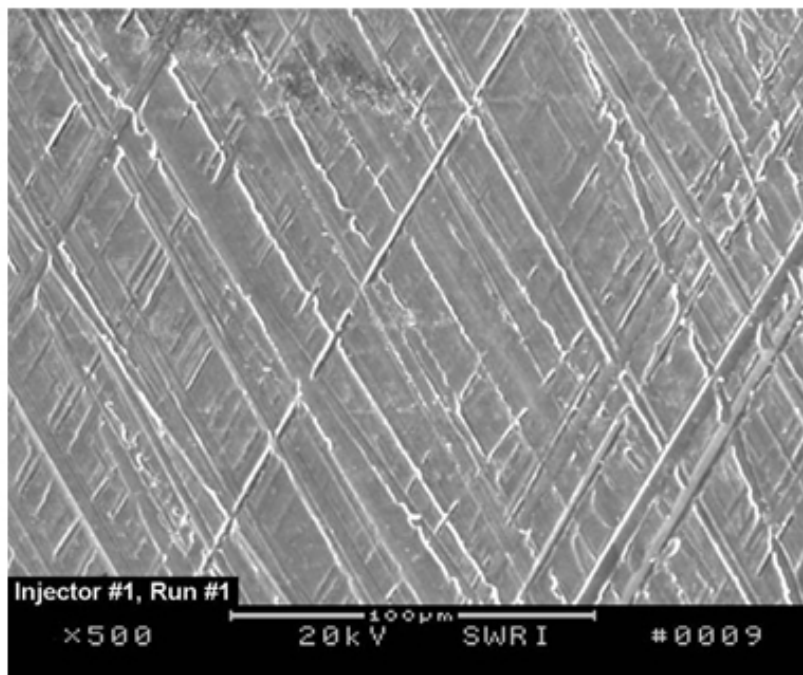
Figure 16. SEM images of the inside surface of the run 1, injector 1 sectioned injector body from (a) within an etched appearing region and (b) outside of the etched appearing region.
